BEACH EROSION CONTROL REPORT

*SOUTH SHORE OF BARNSTABLE
MASSACHUSETTS
FEBRUARY 1977*

SOUTH SHORE BARNSTABLE, MASSACHUSETTS
BEACH EROSION CONTROL REPORT

BEACH EROSION CONTROL STUDY

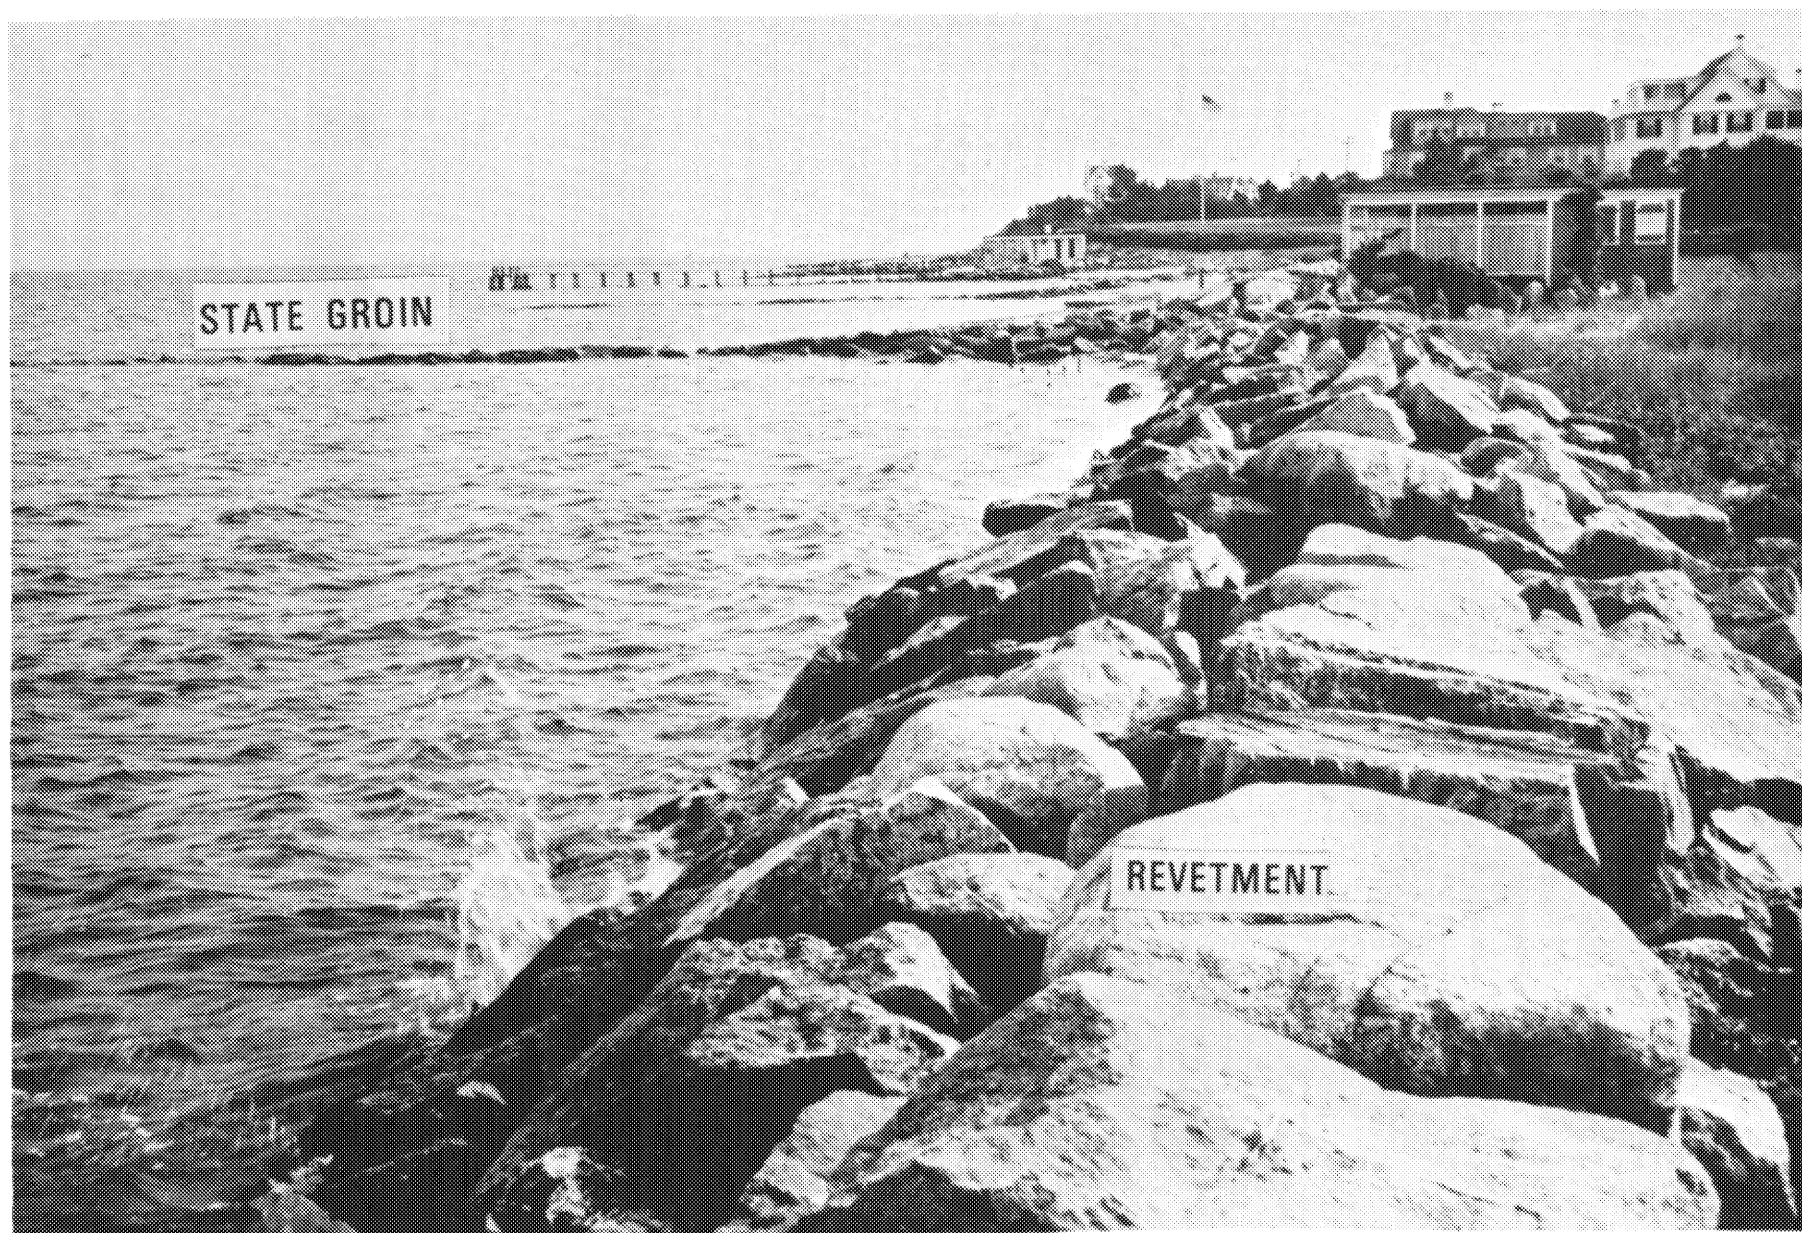
PHOTO 1. July 1971 looking west at Osterville Point (Wianno), note backshore revetment and groin structures constructed by the State to retard the erosion of the shoreline.

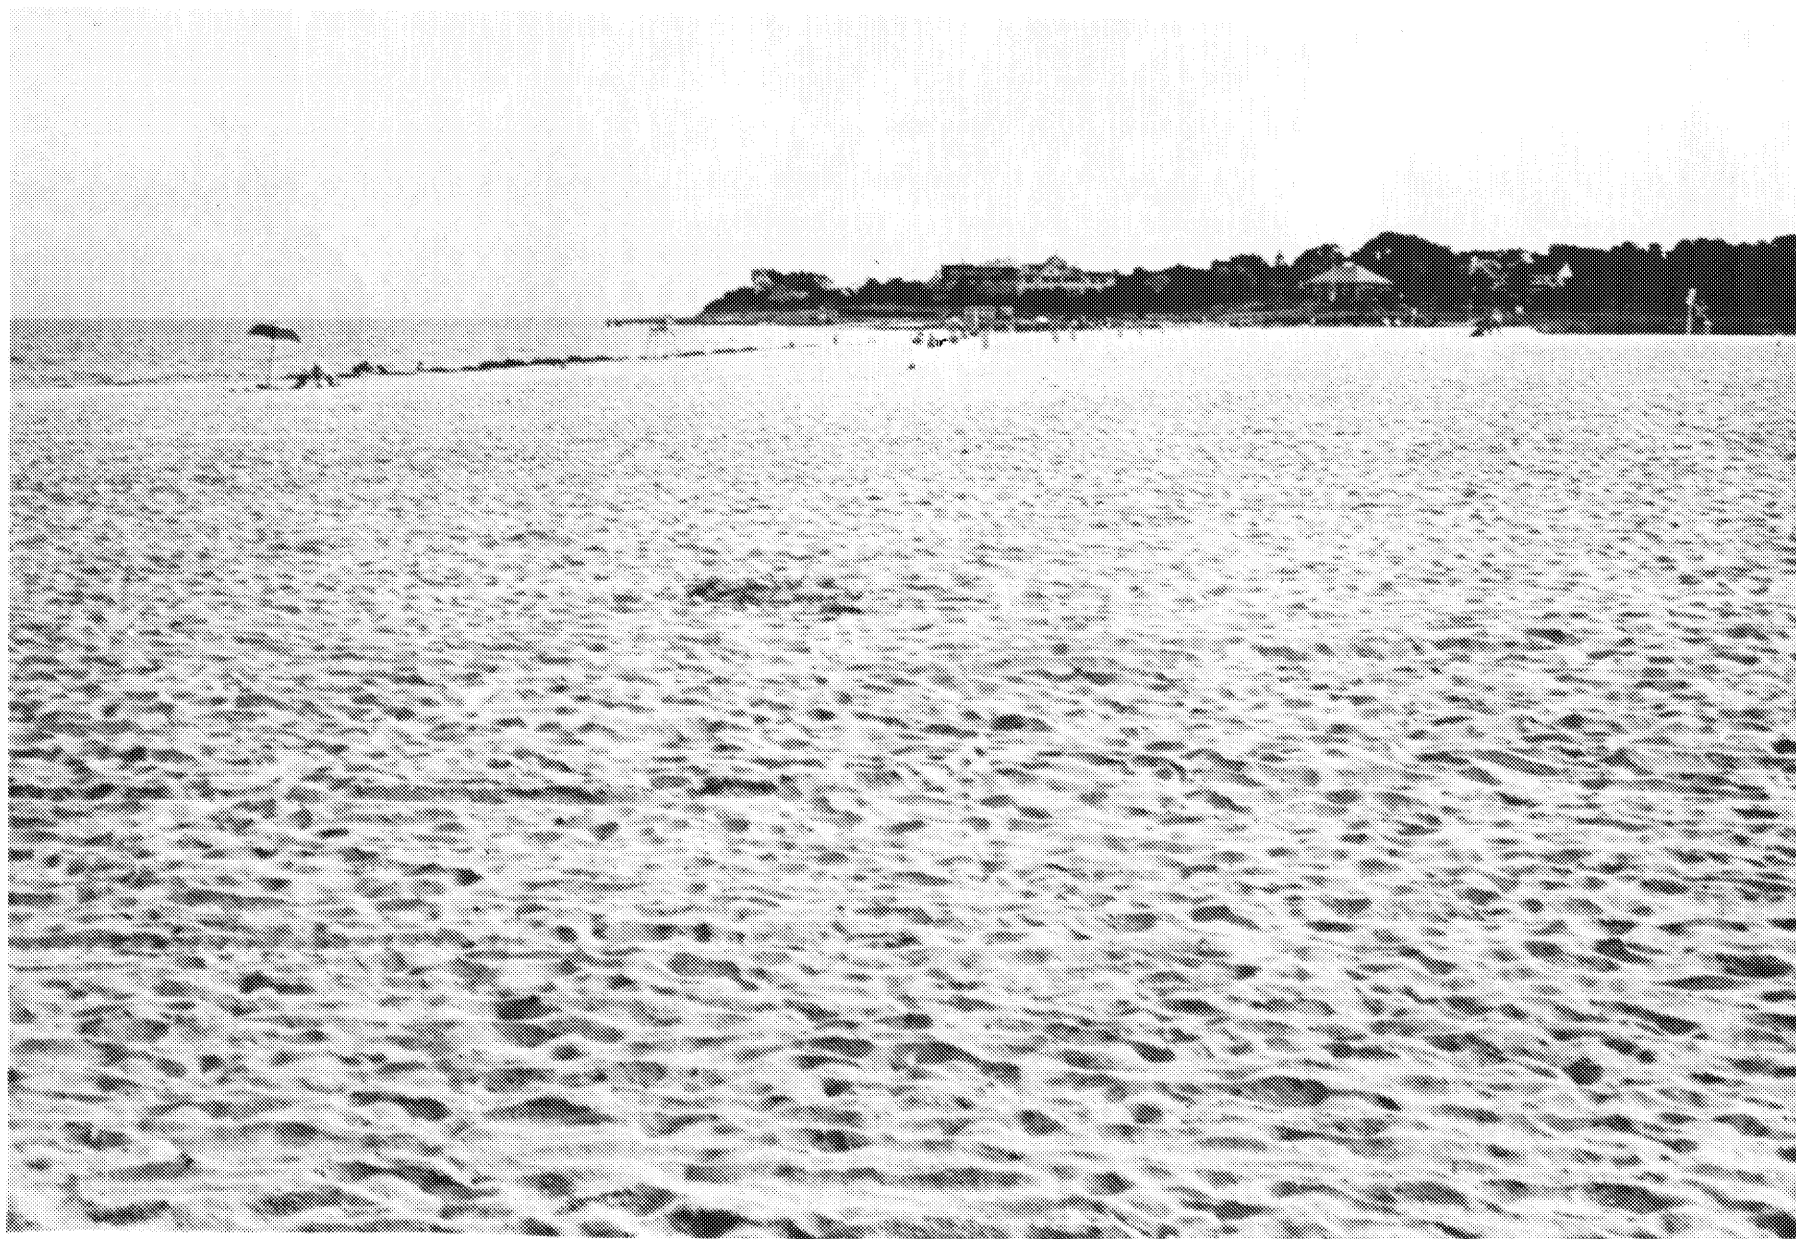
PHOTO 2 July 1971 Dowses Beach, looking west, note wide beach berm at this time of the year.

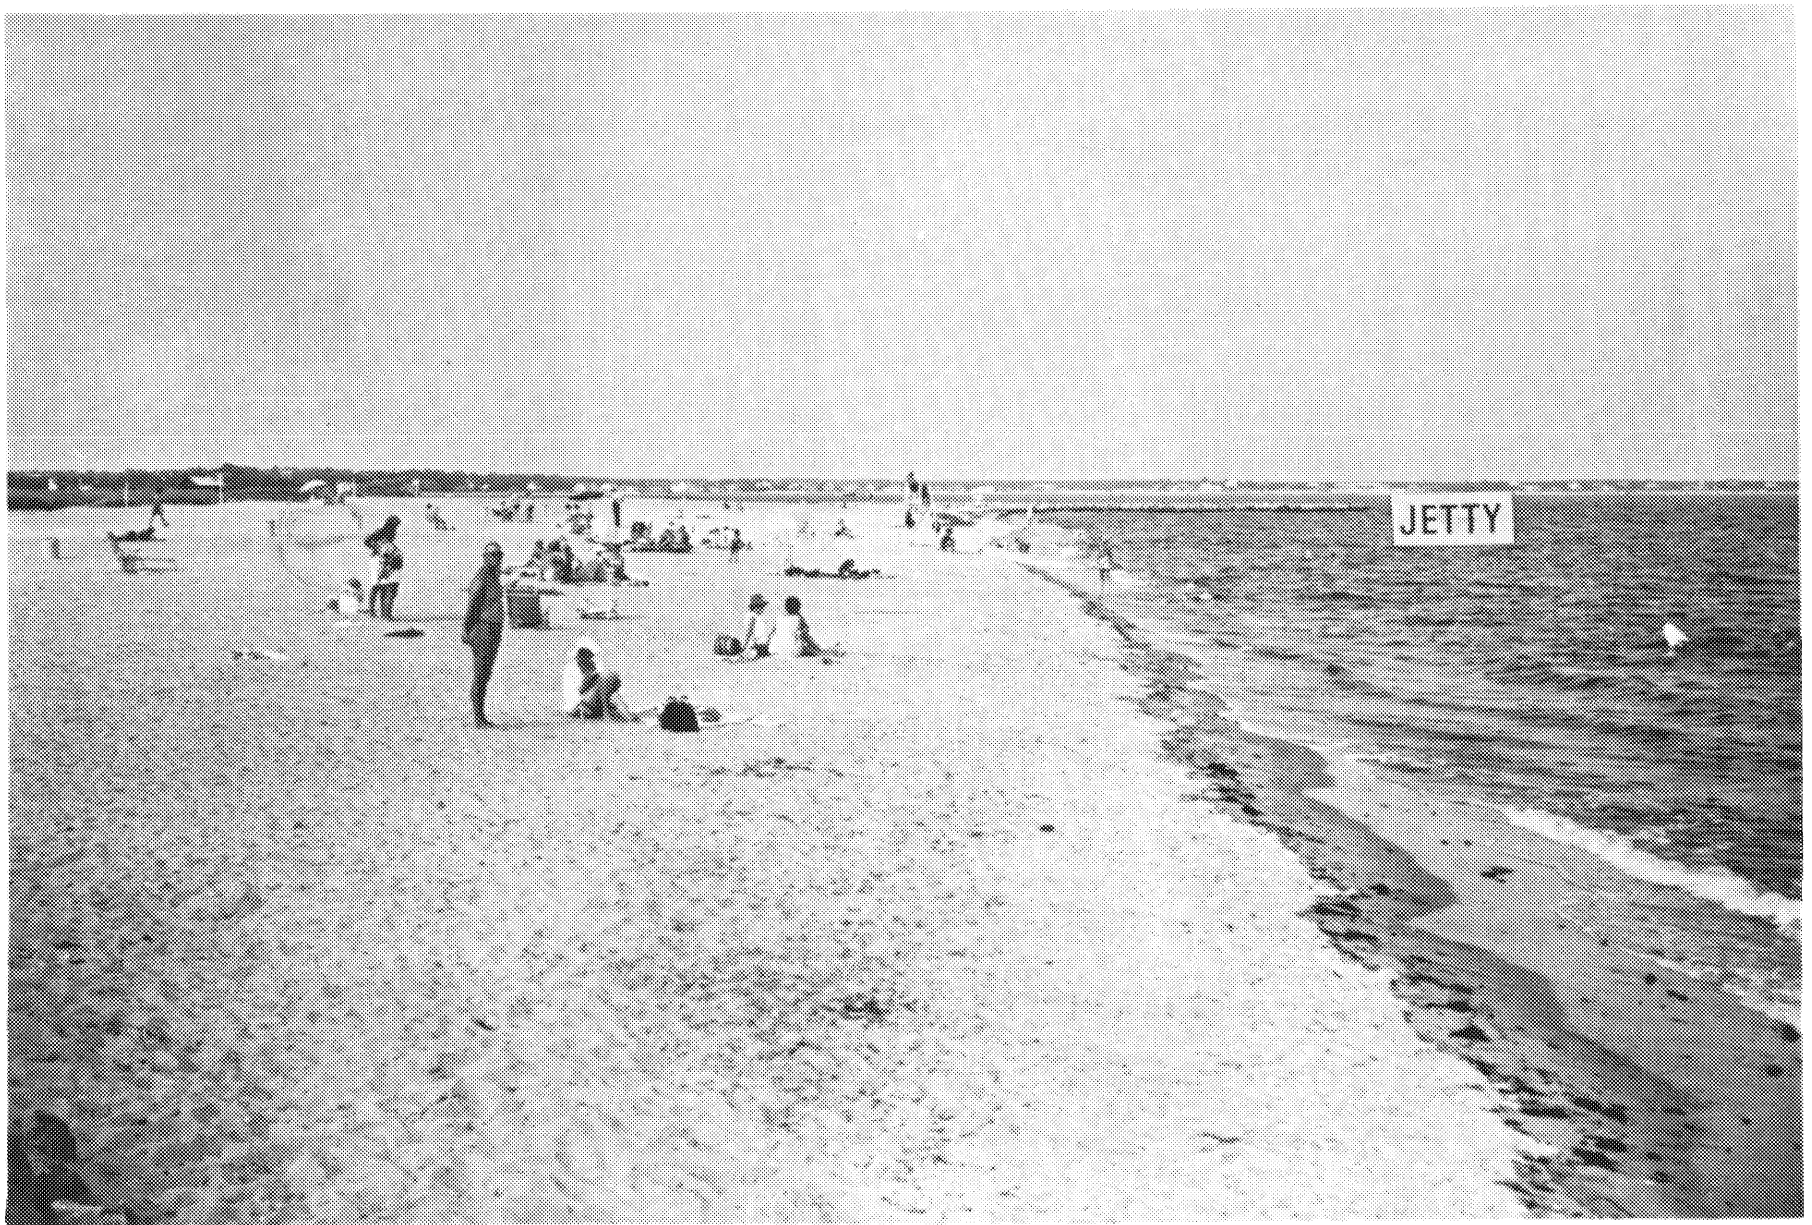
PHOTO 3 - Looking east July 1971 Dowses Beach, note the State jetty structure retaining the sand which would normally be deposited in the channel.

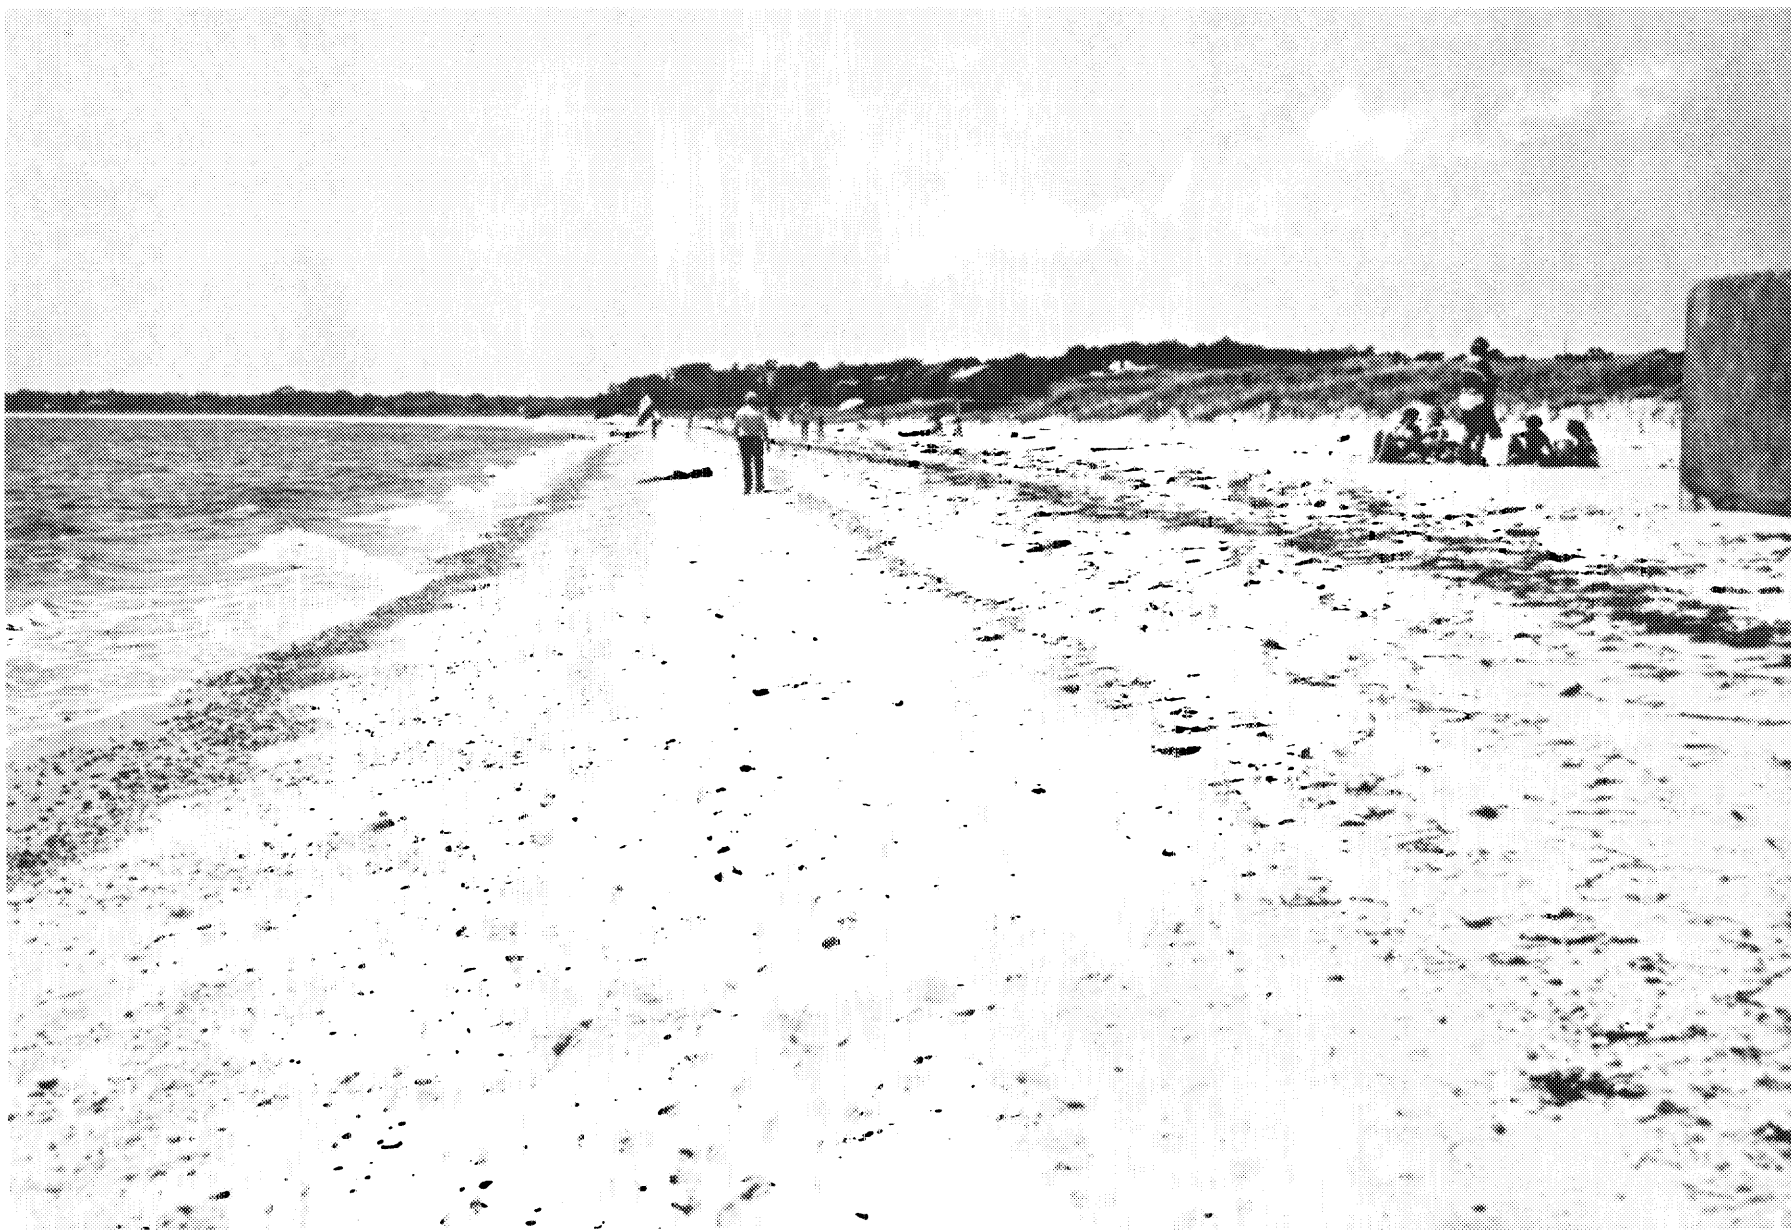
Photo 4. July 1971 looking west along Long Beach at private undeveloped section of the beach.

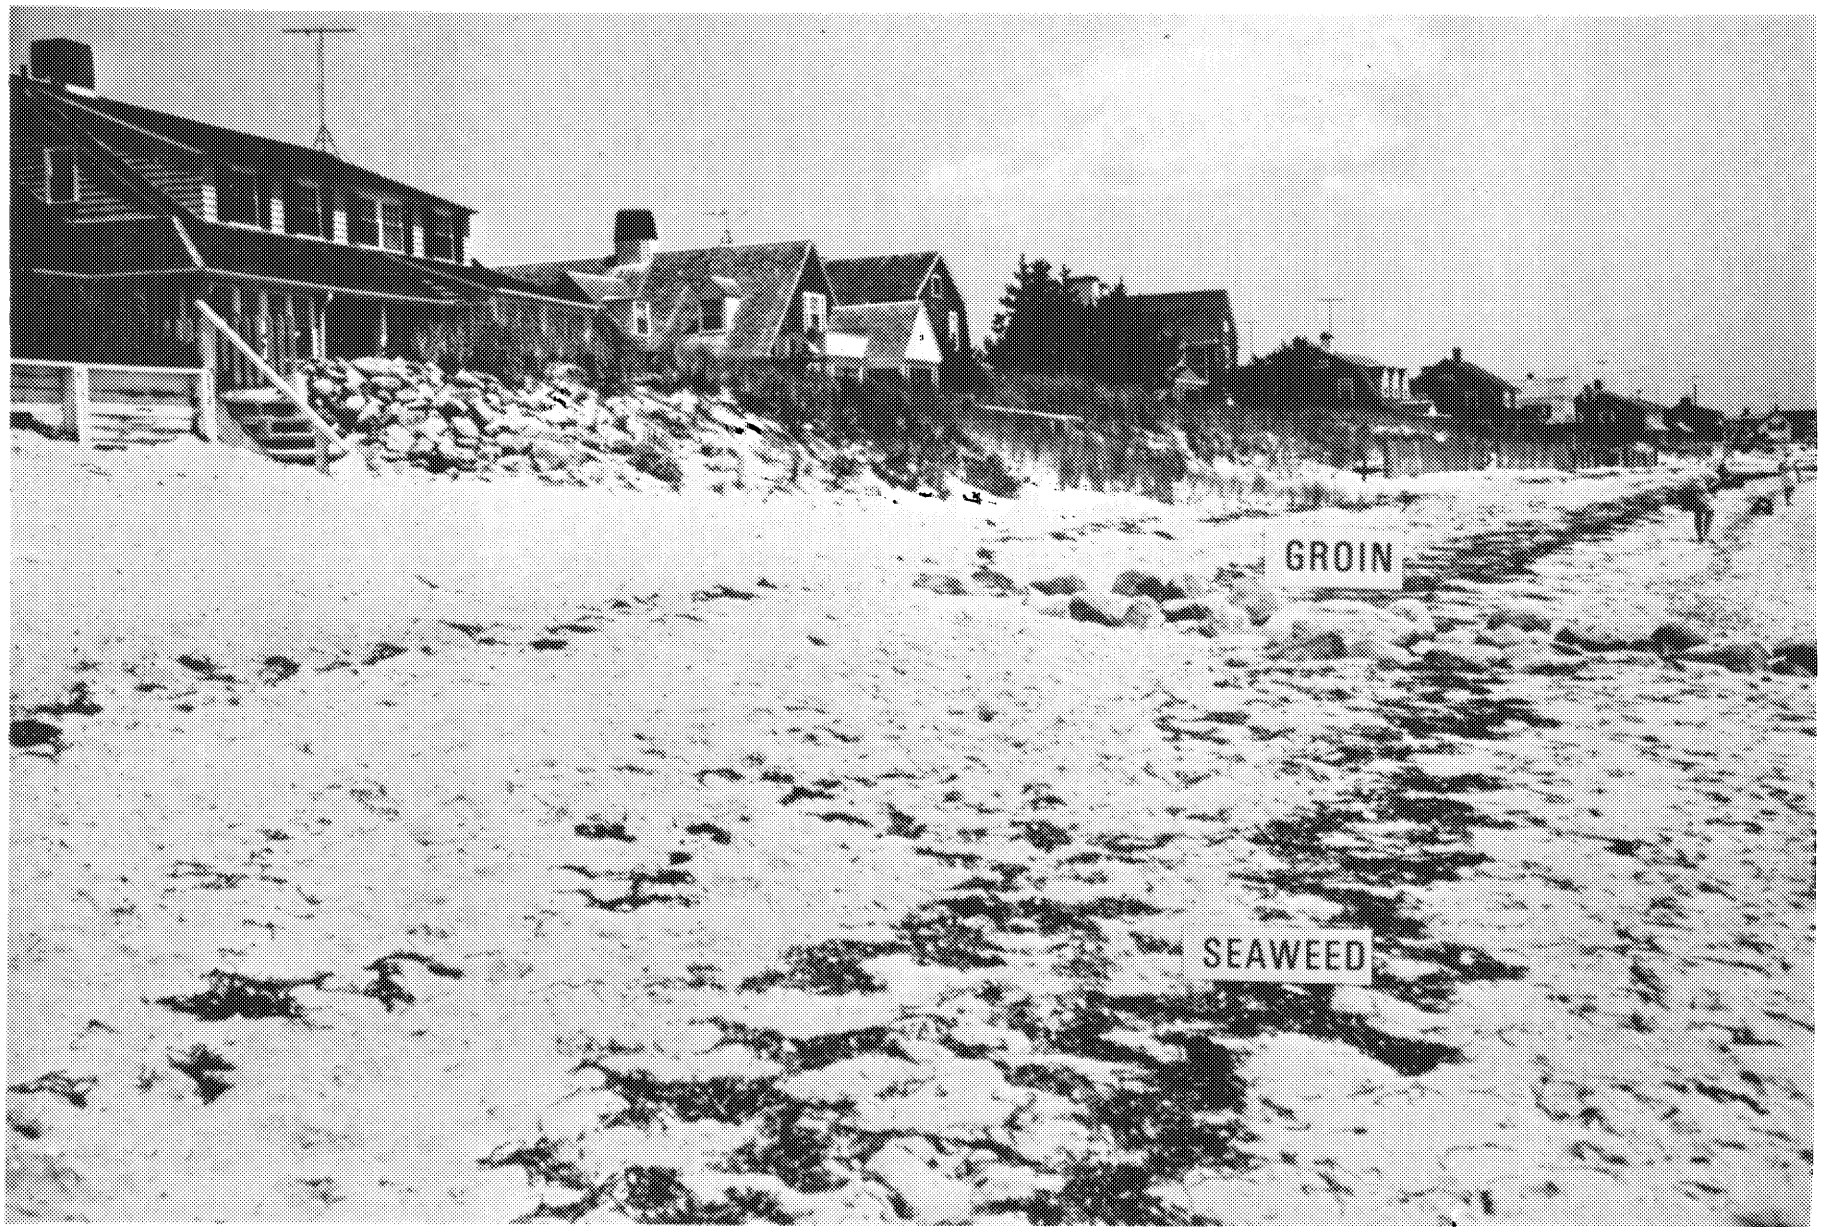
PHOTO 5 July 1971 - Long Beach looking east, note seaweed, indicating approximate high tide, with very limited dry beach width above high tide.

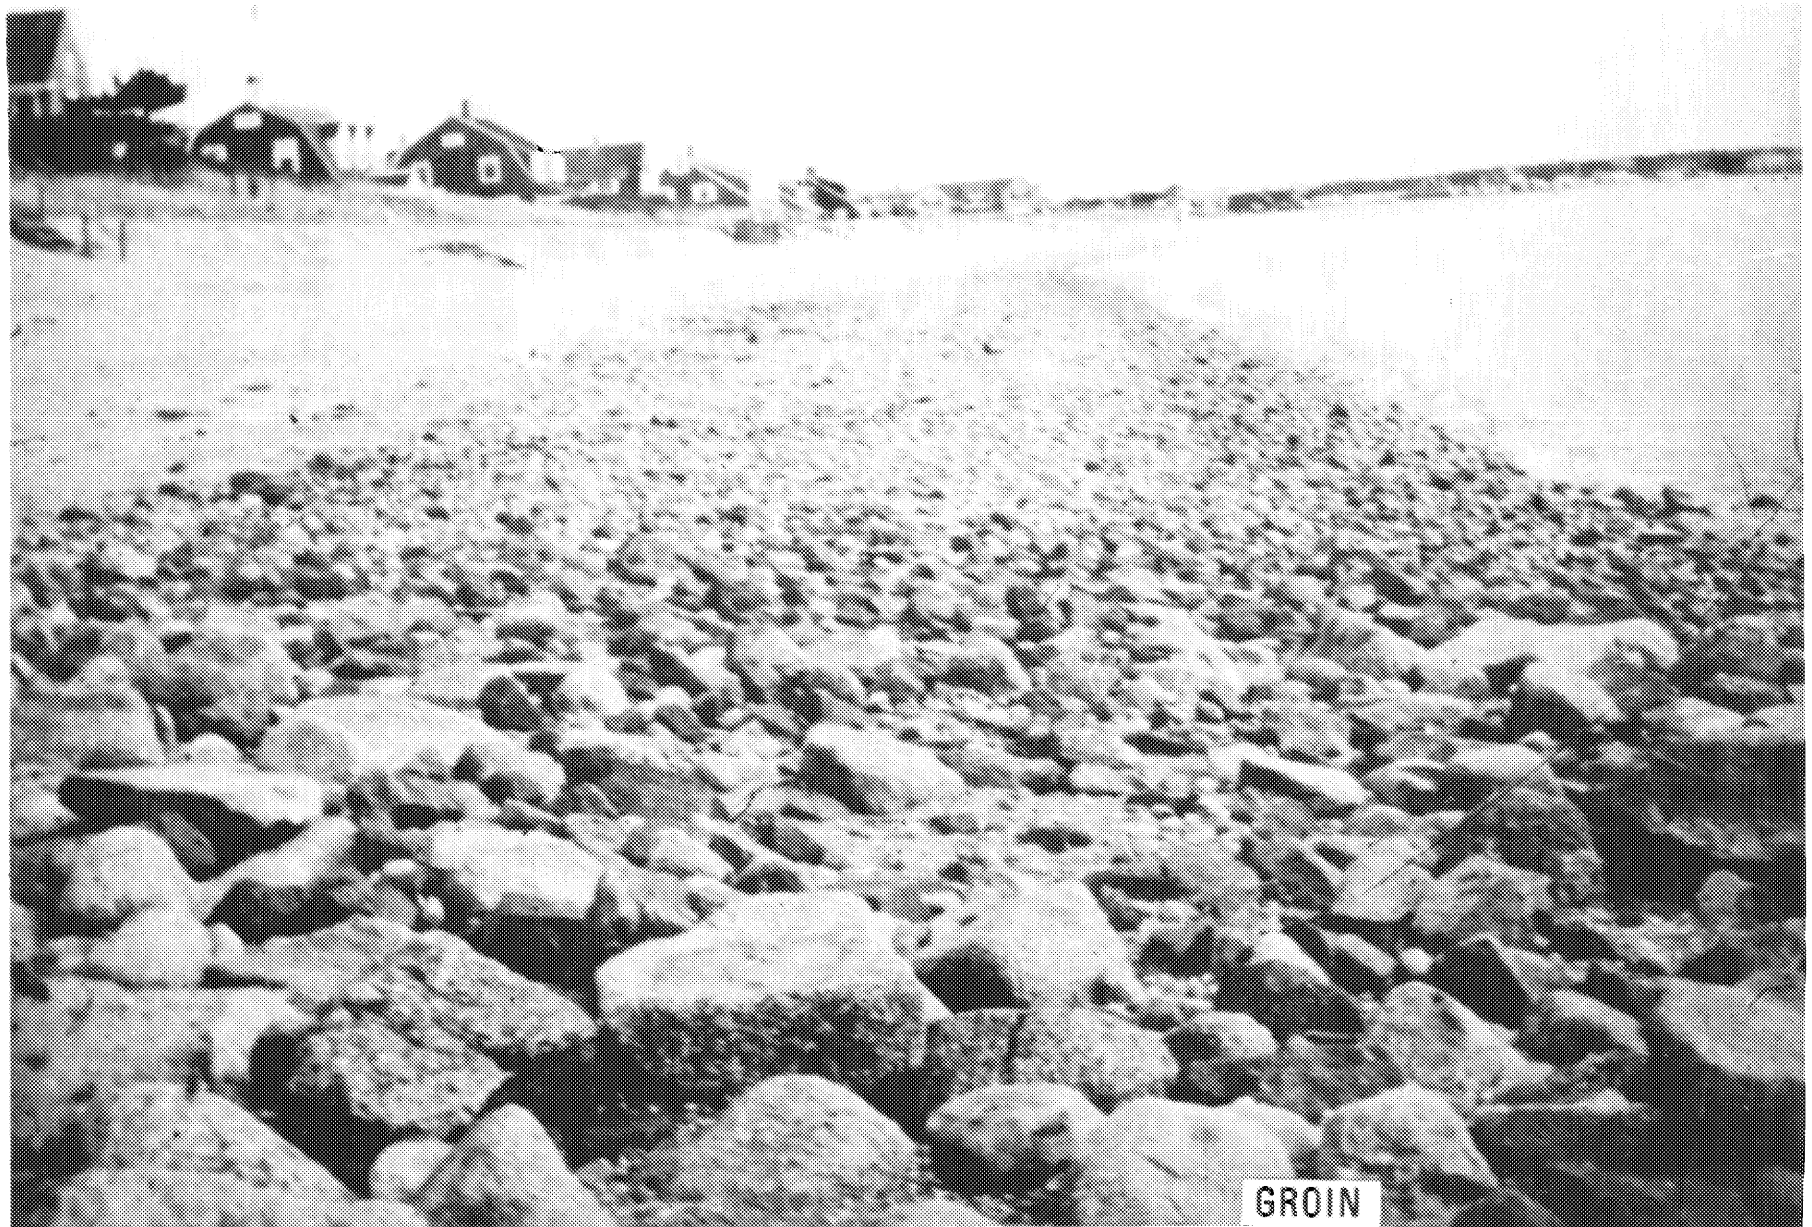
PHOTO 6. Fall 1973 Long Beach - Looking East along the beach, note the rocks, Photo 7 is a photo showing the same area in Fall 1974

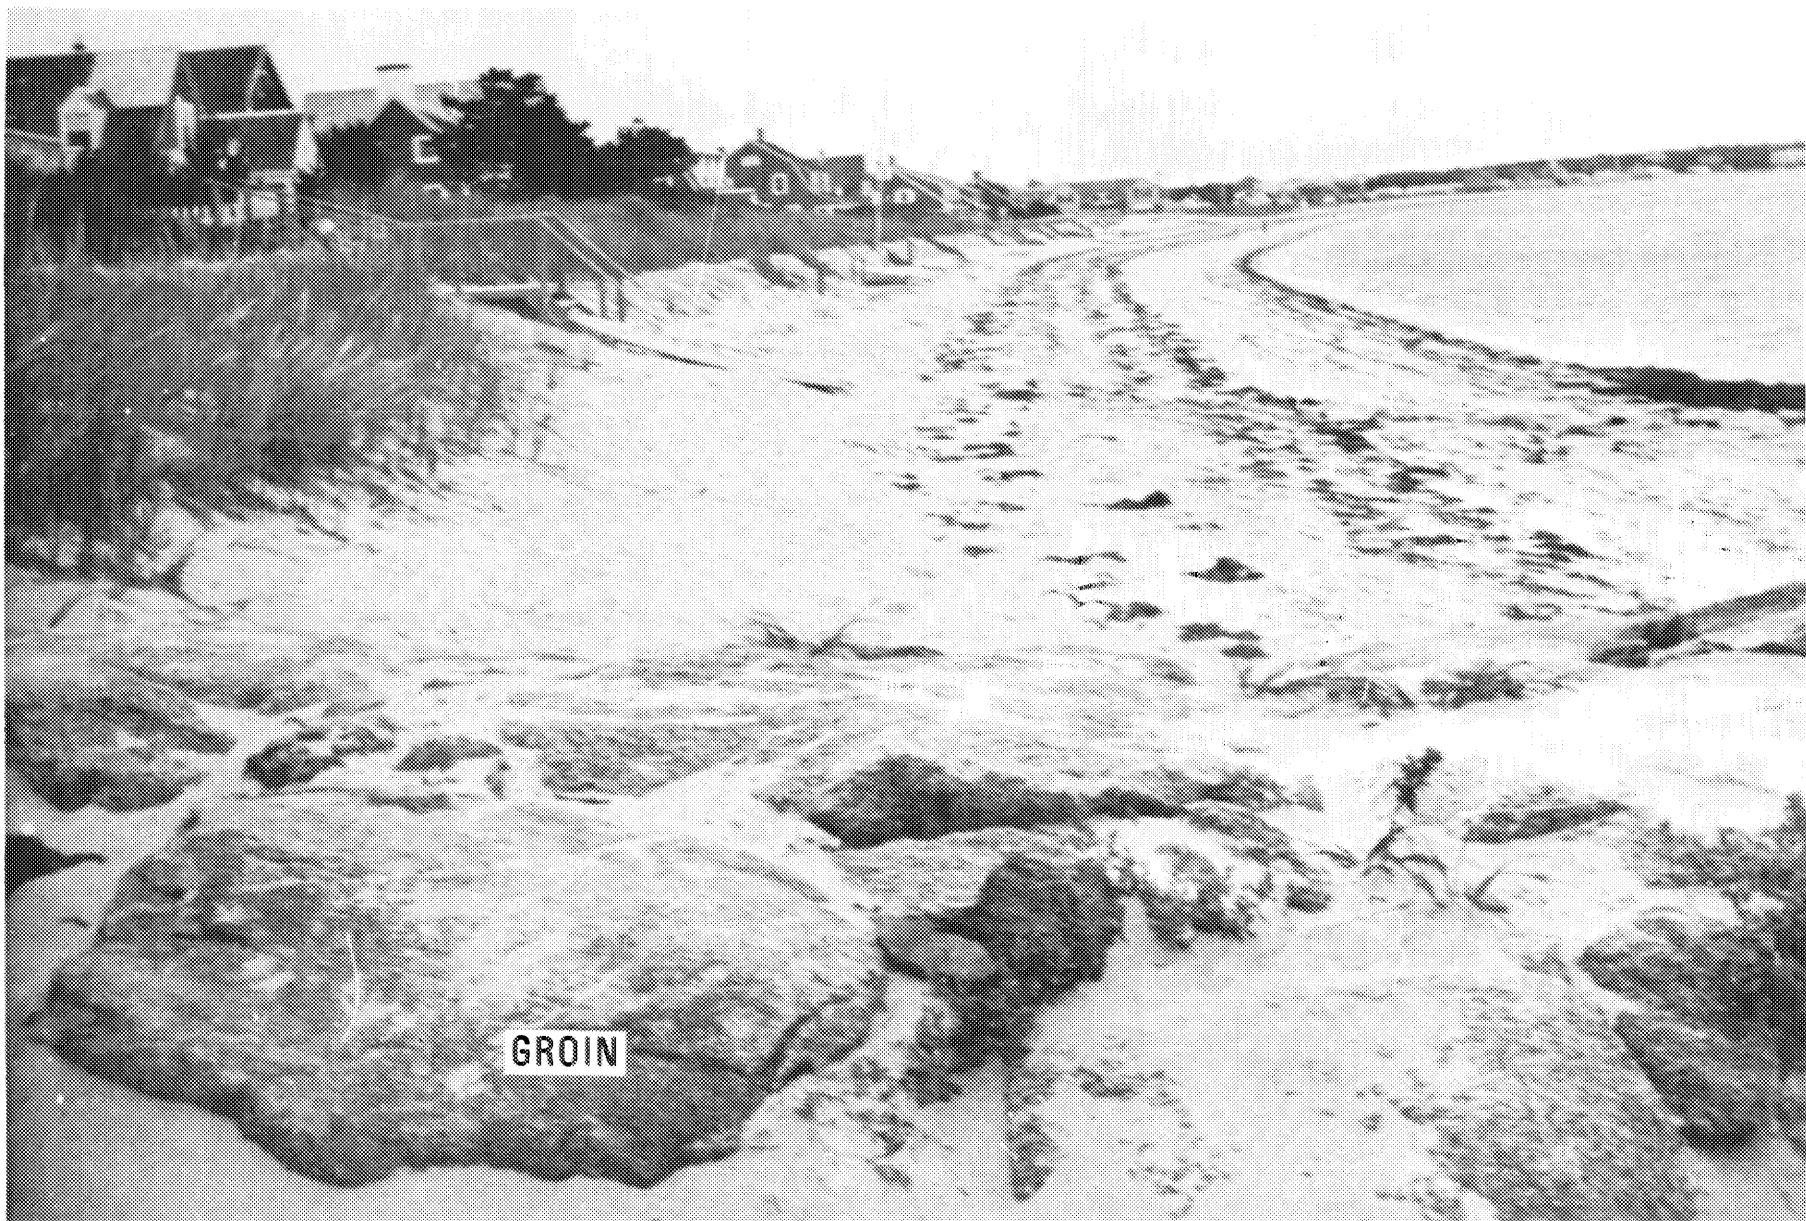
PHOTO 7. Fall 1974, looking east along Long Beach. Note Photo 6 and rock exposure. This photo shows rocks now covered.

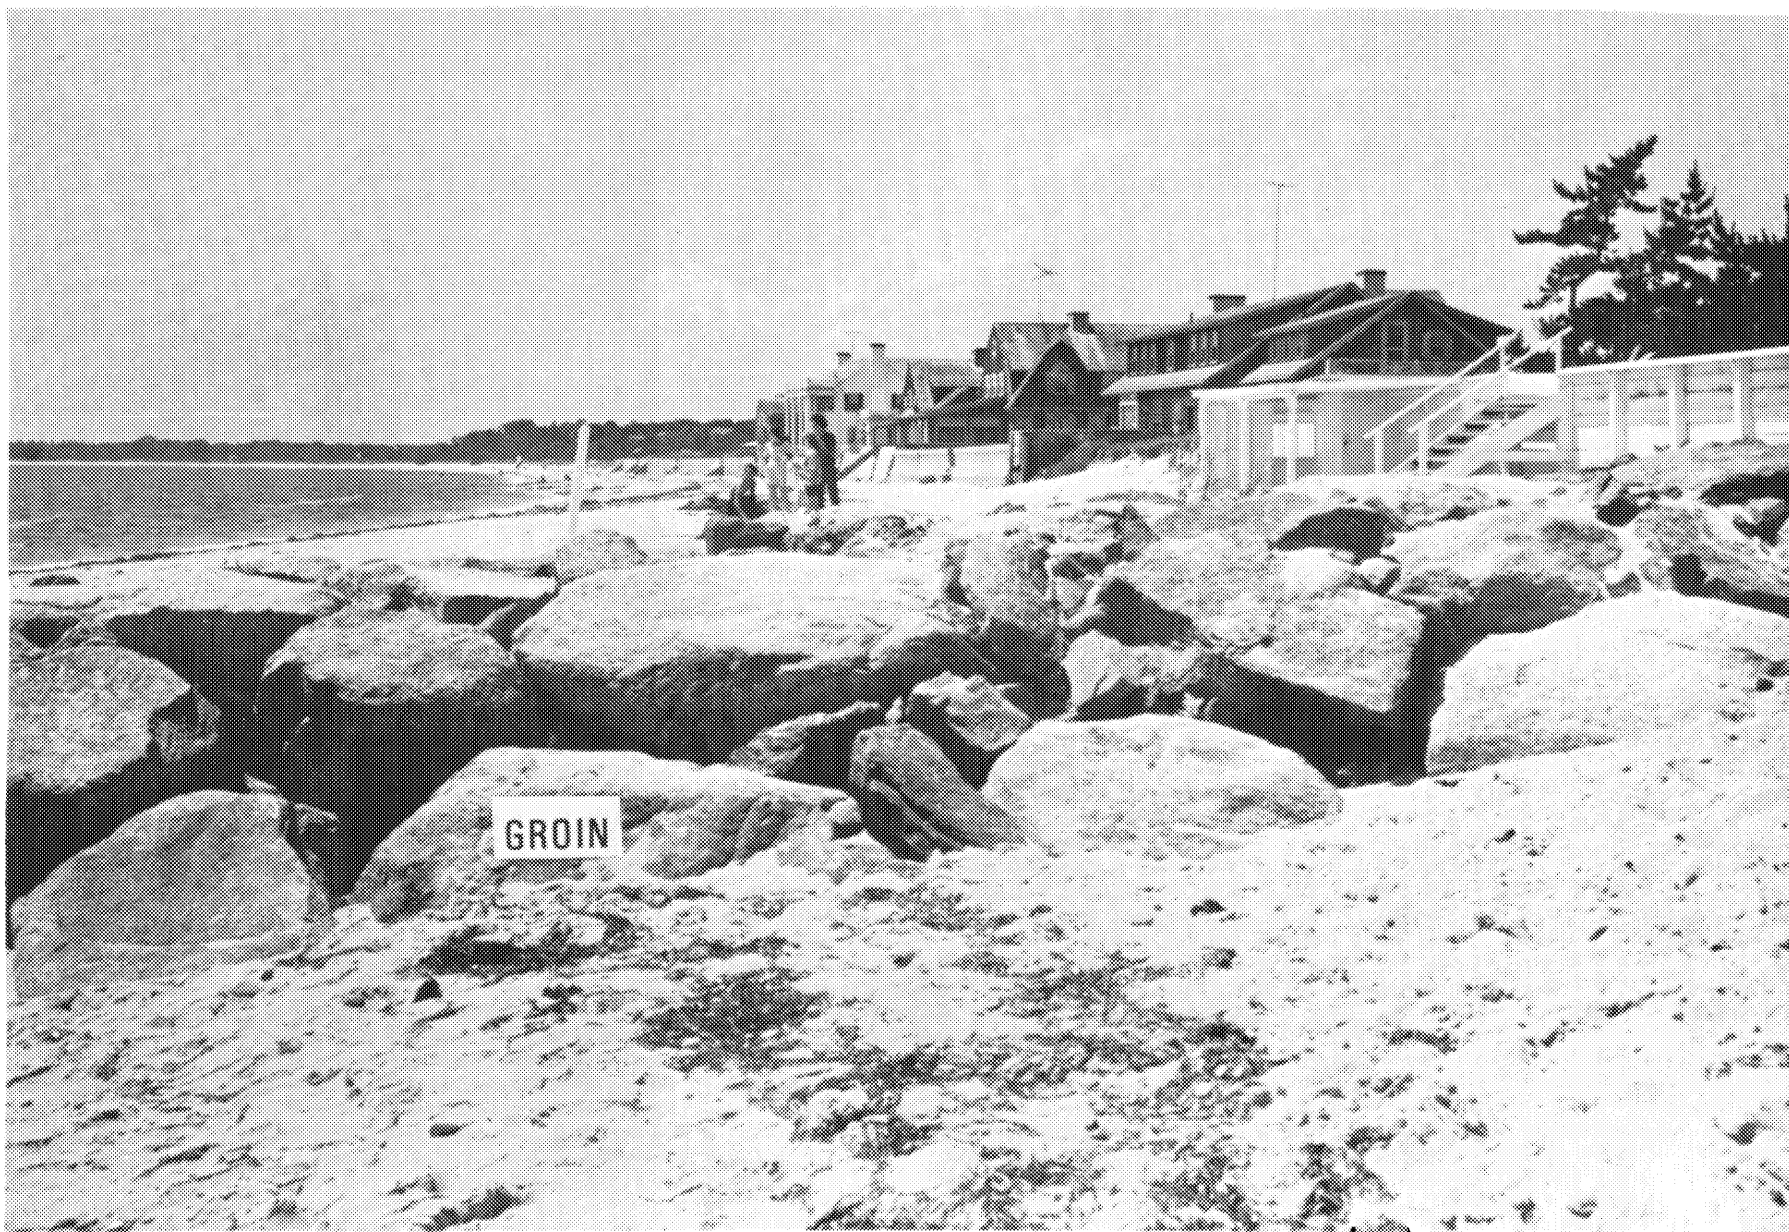
PHOTO 8. July 1971, looking west along Long Beach, Mr. Goldberg's groin in the foreground. Note some difference in sand buildup at this time of the year.

A stone groin was constructed on Long Beach by a local resident, in 1970, in an attempt to reduce erosion in front of his property by gaining additional beach width. Immediately following construction of the groin the beach to the eastward side showed an acceleration in erosion due to the interruption of littoral drift. This situation caused property owners to construct massive riprap revetment on the face of sand dunes along the backshore to protect their property. The property owner who constructed the groin subsequently replaced a wooden bulkhead fronting his property with stone riprap to provide a more substantial structure. He then placed about 1,800 cubic yards of sand on both sides of the groin building the dry beach area seaward for a distance of 20 feet. The eastward drift of sand has now filled the west side of the groin and material is moving past the groin to nourish the eroded area which resulted from its construction. The beach on the downdrift side of the groin has widened noticeably indicating that littoral movement has been resumed.

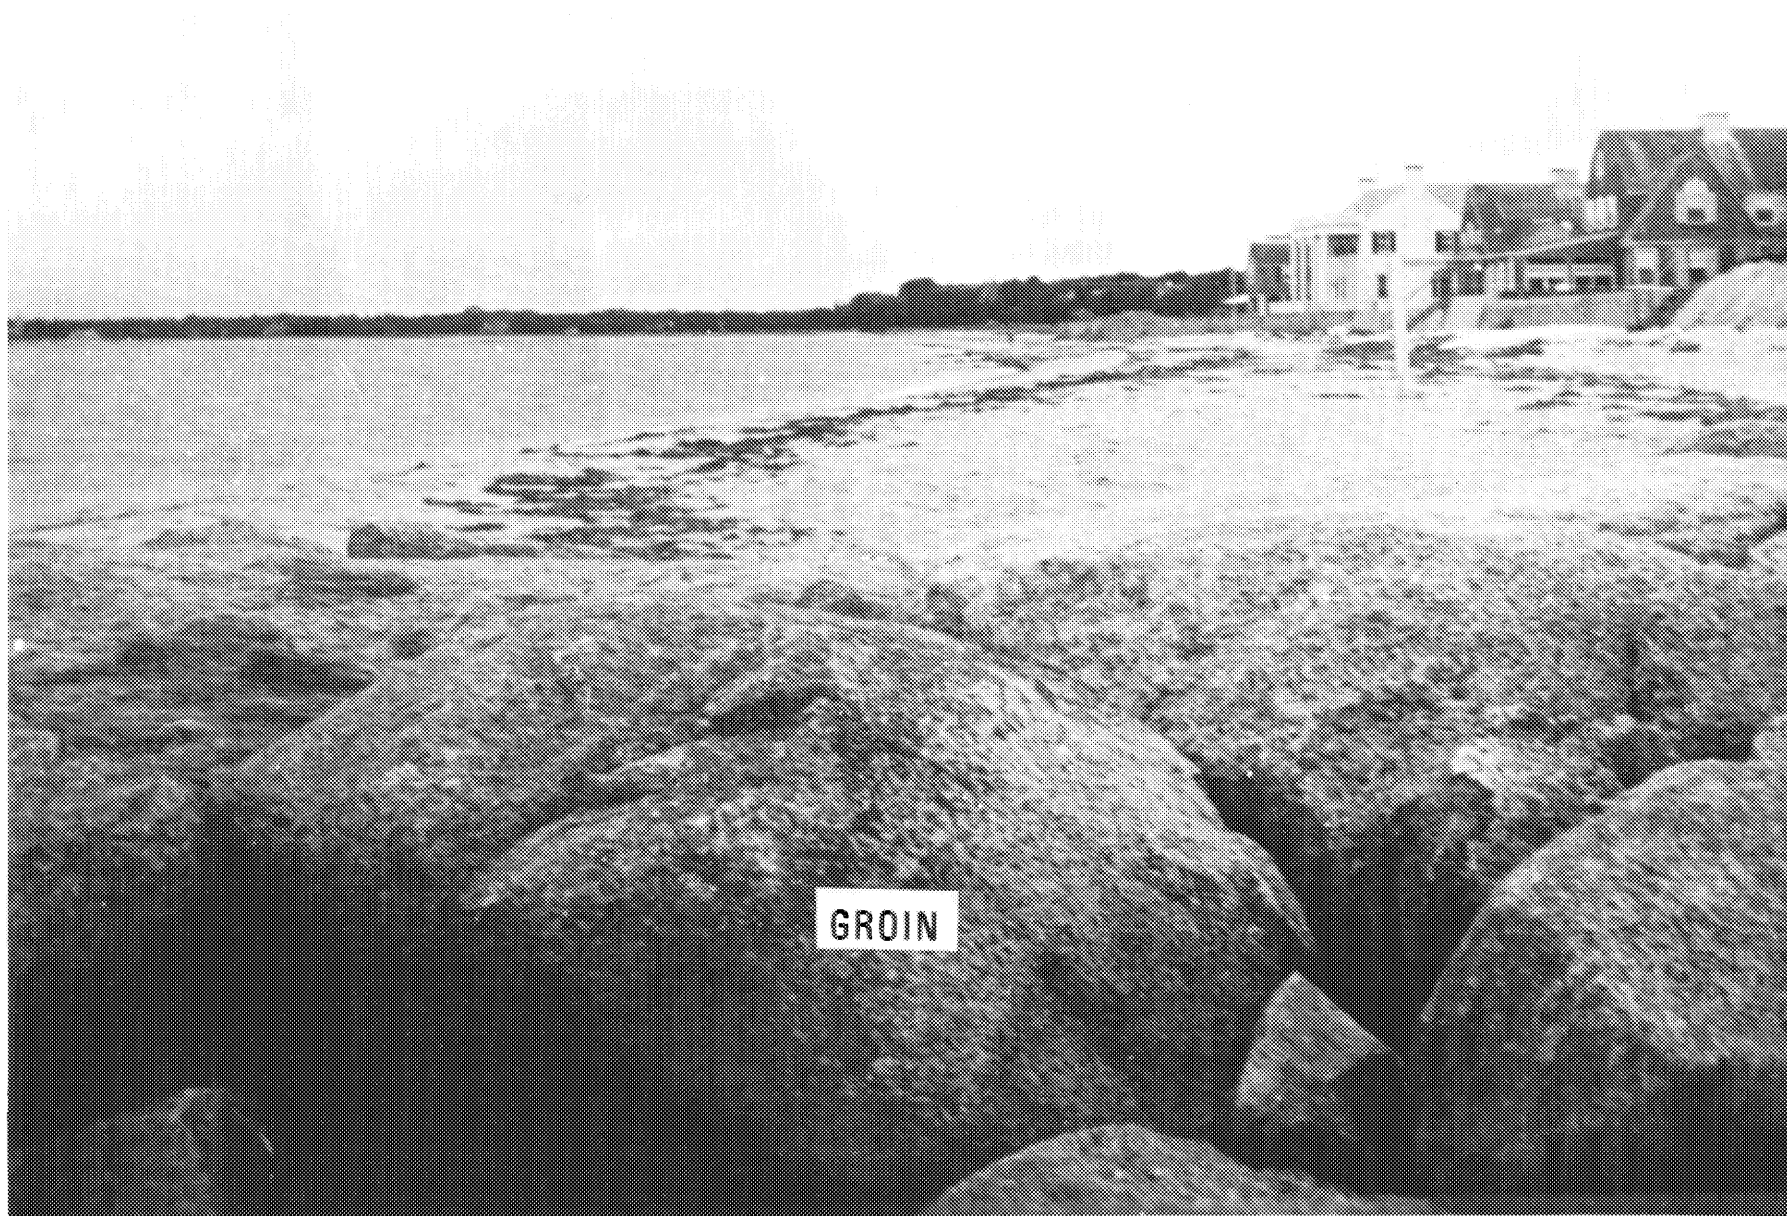
PHOTO 9. Fall 1974, looking west from Mr. Goldberg's groin, note dry beach area line, right side of photo is reduced compared to dry beach in Photo 8.

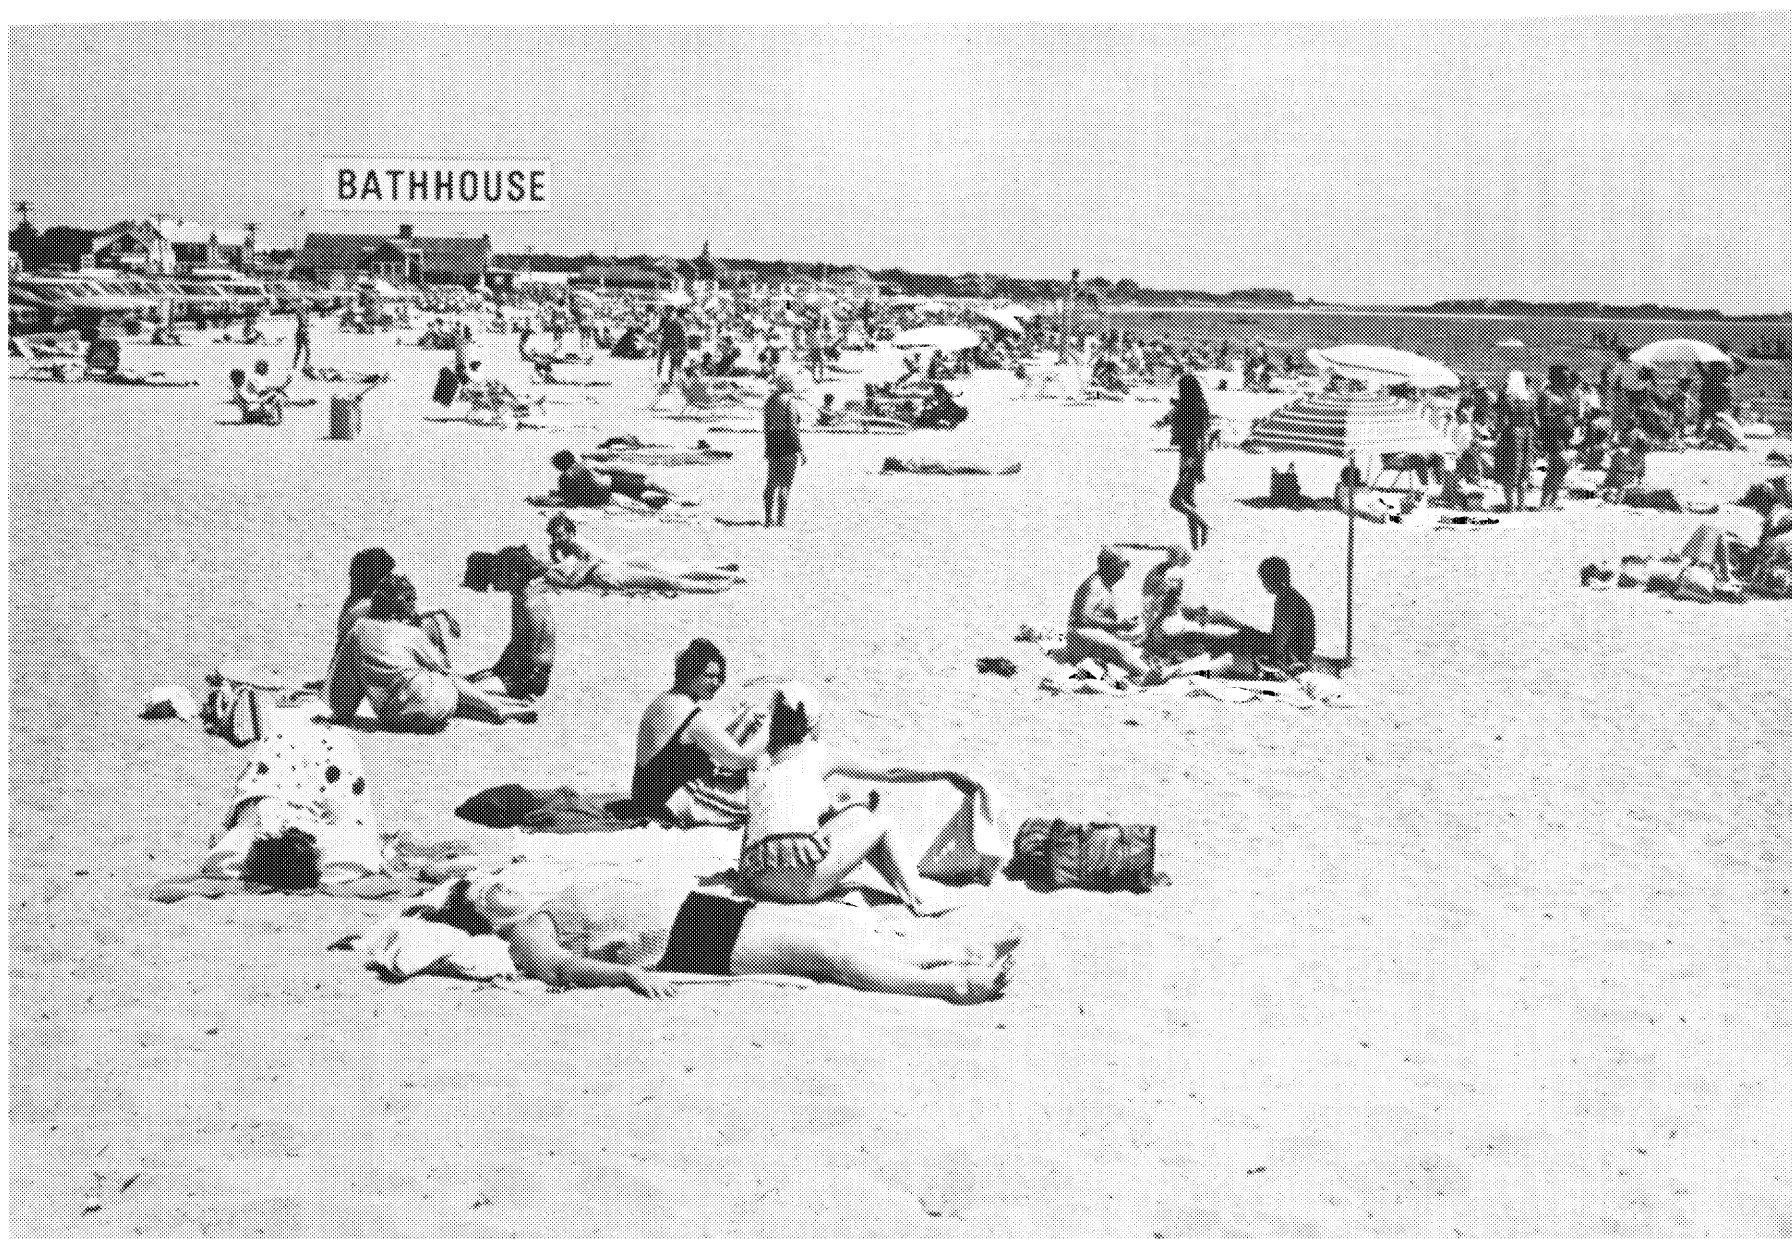
PHOTO 10. July 1971 Craigville Beach looking east, note wide beach bathing area at about high tide.
